CORNELIS DAM

CT 00293

PHASE 1 INSPECTION REPORT
NATIONAL DAM INSPECTION PROGRAM

MARCH, 1981

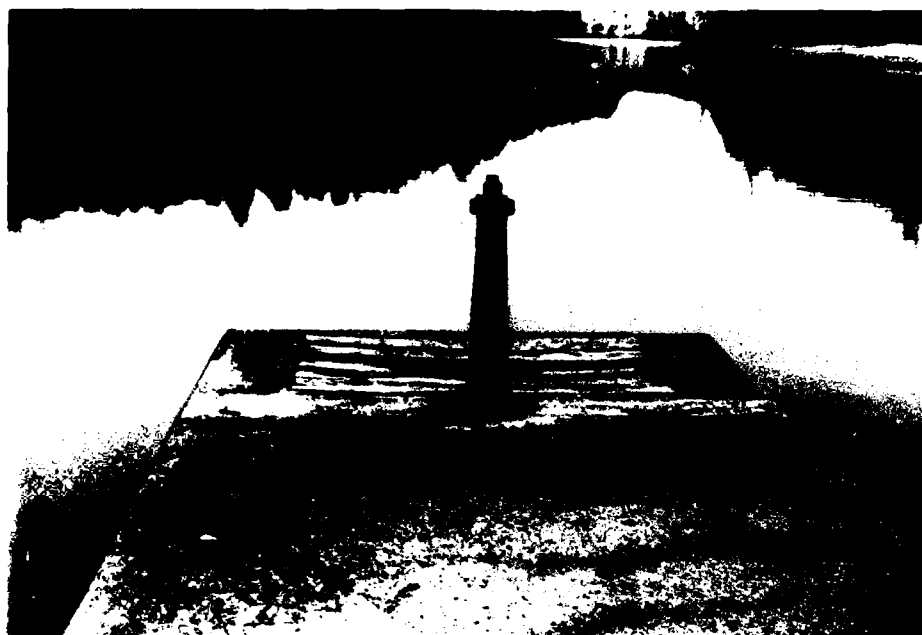
C-9 VALVE STEM FOR OUTLET WORKS

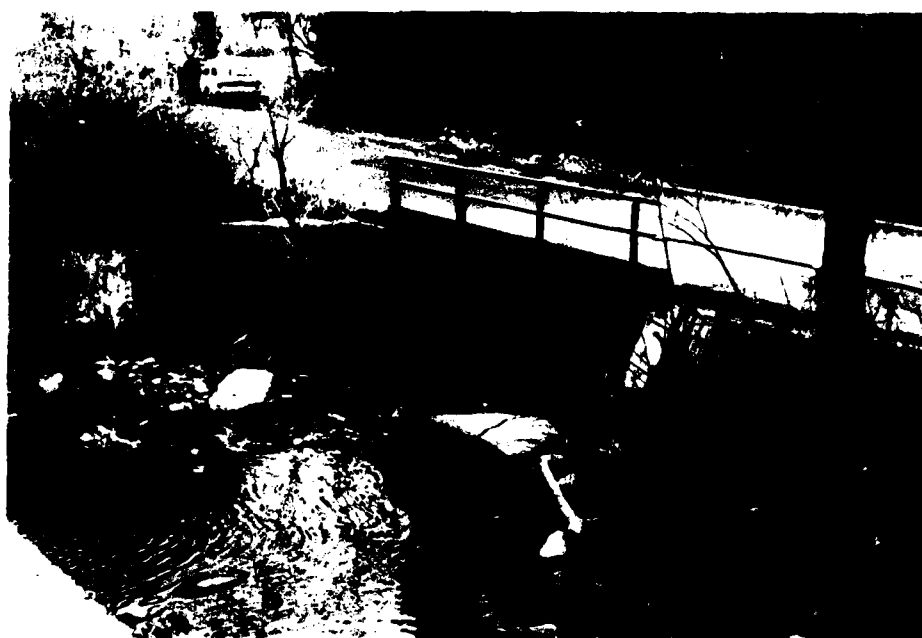
2. **Eastern Spillway:** This spillway is a 75 foot long concrete weir (Photo C-5 and C-6). The face is cracked and spalled near the central abutment (Photo C-8). The entire spillway was flowing on the day of the inspection. The east abutment is concrete and is generally in good condition. There are two weepholes in the abutment below the spillway which were seeping. The concrete around the weepholes and further downstream to the road is spalled and chipped (Photos C-6 and C-11). There is a tree growing between the spillway and road (Photo C-11).

C-11 BRIDGE BELOW EAST SPILLWAY

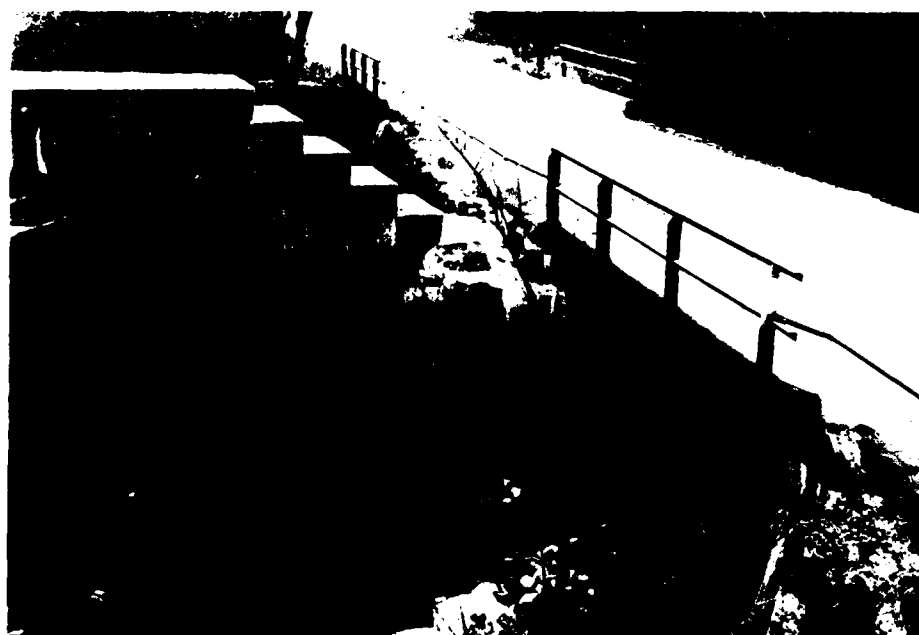
C-12 BRIDGE BELOW WEST SPILLWAY

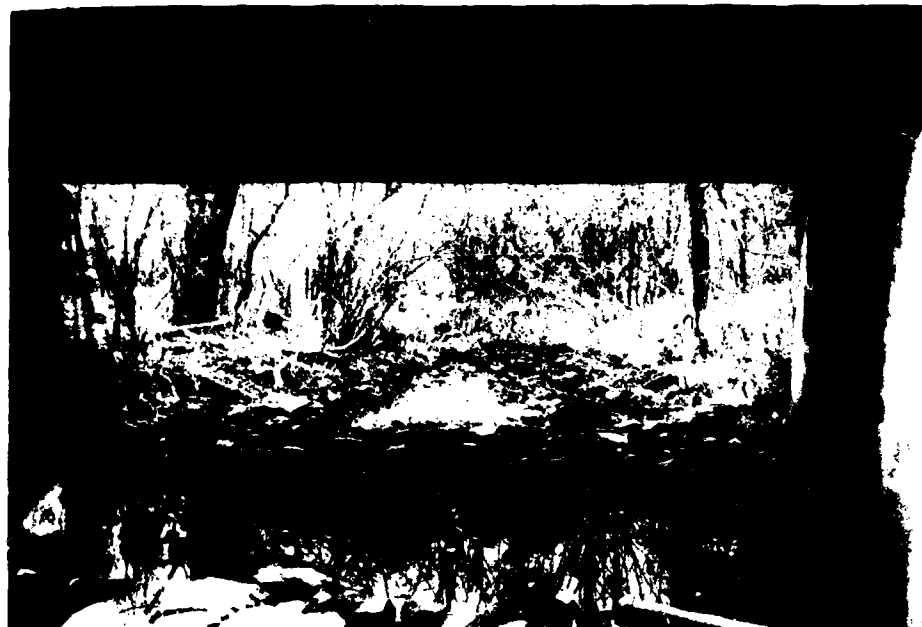
C-13 DOWNSTREAM CHANNEL BELOW WEST
SPILLWAY
